CRYSTAL LAKE DAM

JEFFERSON COUNTY, MISSOURI

MO 30462

# PHASE 1 INSPECTION REPORT NATIONAL DAM SAFETY PROGRAM

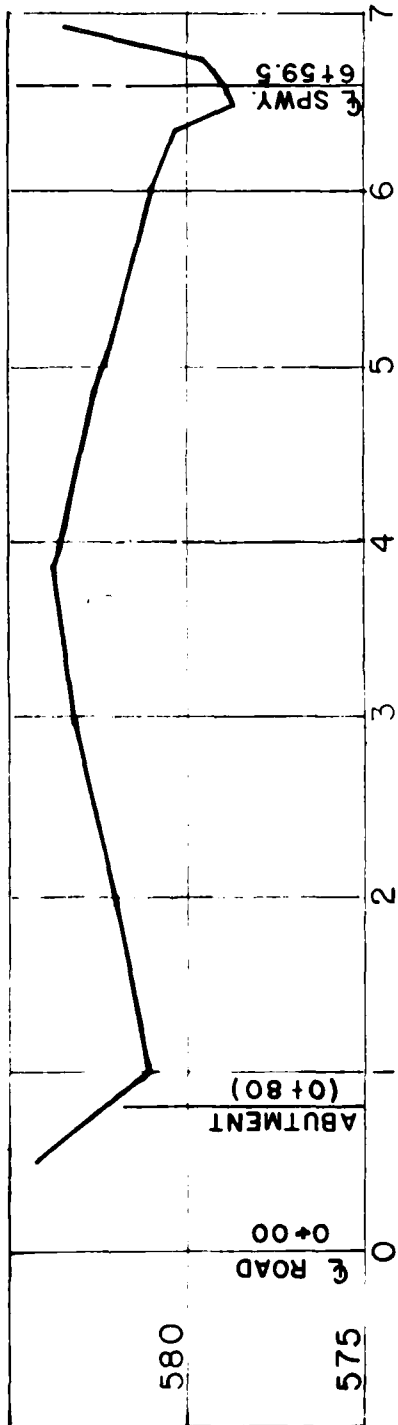
PROFILE DAM CREST  
SCALES: 1" = 5' V., 1" = 100' H.

The elevation of the top of the dam near the right (looking downstream) abutment, as determined by survey, was found to be approximately 3 feet lower than the top of dam in the area near the center of the dam. A profile of the dam crest centerline is shown on Plate 3.
